Manhole Inspection Summary

Manhole # S27C__019MH

Insp Date: **12/10/07 12:58 PM**

Location Address: **928 FRANKLIN ST**

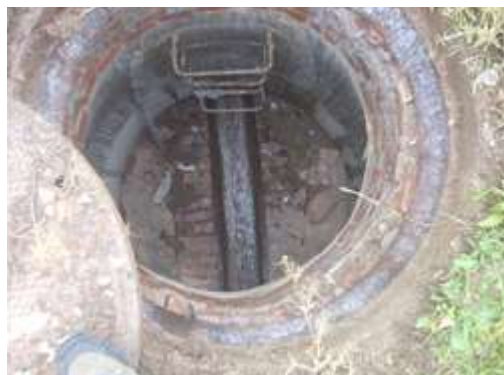
Top View

Surcharge ☒ **Evidence Of Surcharge** Depth: **3** (ft.) ☐ Active Surcharge Present

SURCHARGE EVIDENCE ON 2ND STEP

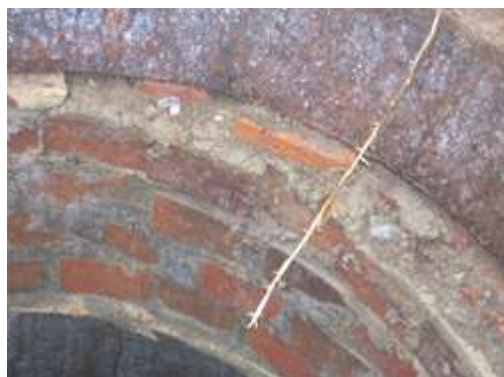
Defect 3

Condition: ☐ Sound ☒ **Cracked** ☐ Root Intrusion ☐ Loose Brick ☐ Deteriorated

CRACKED CORBEL

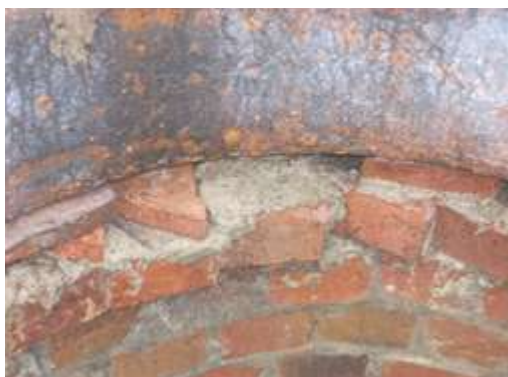
Defect 2

Condition: ☐ Sound ☐ Cracked ☐ Root Intrusion ☐ Loose Brick ☒ **Deteriorated**

CHIMNEY DETERIORATION

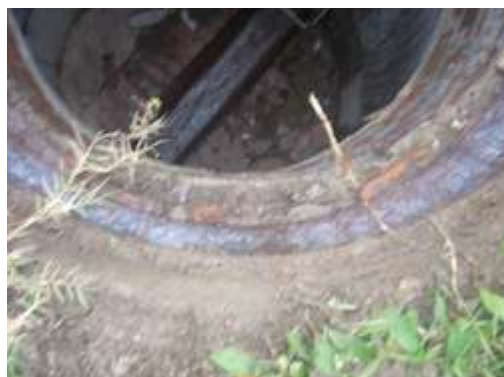
Defect 1

Frame Offset: **2** (in.) Condition: ☒ Sound ☐ Cracked ☐ Leaks

FRAME OFFSET

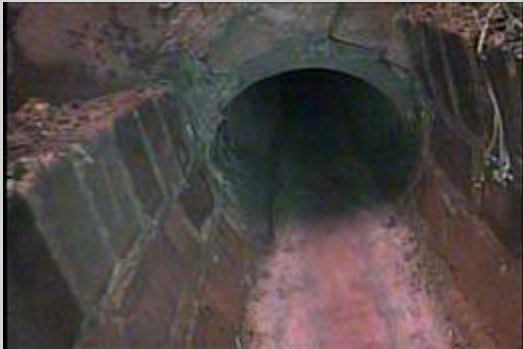
12 O'Clock Outflow

10 in. Circular Gravity Sewer
Pipe Out @ 12 O'Clock

Pipe Height: **9.6** (in.) Rod and Bar (Angled)
Pipe Material: **Clay** ☐ Pipe Lined
Invert Depth: **7.91** (ft.) Flow Characteristics: **Fast**
Deposits: ☒ None ☐ Mud ☐ Sludge ☐ Debris ☐ Grease
Silt Depth: (in.) Deposits Extent:
Infiltration: **None** Pipe Seal Cond: **Sound**

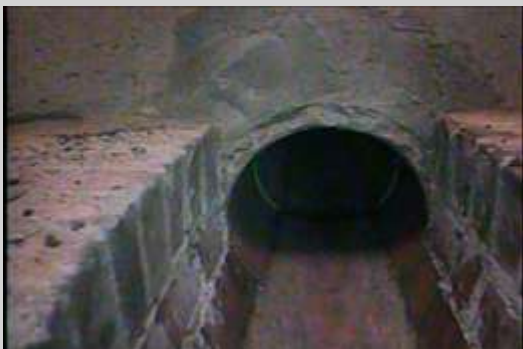
6 O'Clock Inflow

10 in. Circular Gravity Sewer
Pipe In @ 6 O'Clock

Pipe Height: **9.6** (in.) Rod and Bar (Angled)
Pipe Material: **Clay** ☐ Pipe Lined
Invert Depth: **7.82** (ft.) Flow Characteristics: **Fast**
Deposits: ☒ None ☐ Mud ☐ Sludge ☐ Debris ☐ Grease
Silt Depth: (in.) Deposits Extent:
Infiltration: **None** Pipe Seal Cond: **Sound**
